Earthquake Resistant Non-Engineered Construction in Developing Countries Utilizing Appropriate Technology

Teddy Boen¹, Hiroshi Imai², Lenny¹ and Sarah E. Suryanto¹

ABSTRACT

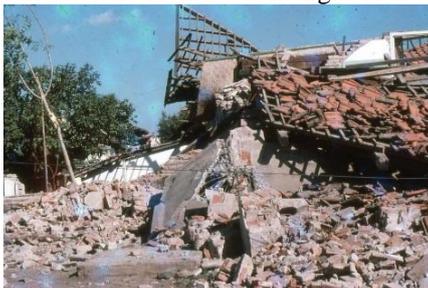
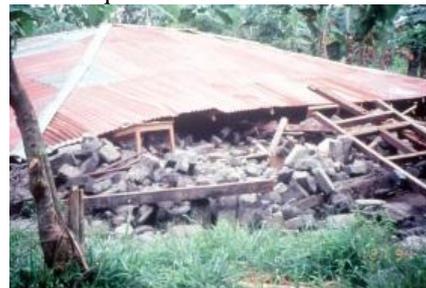
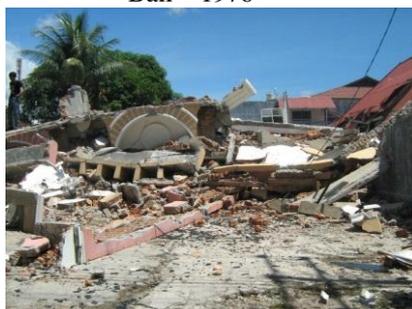
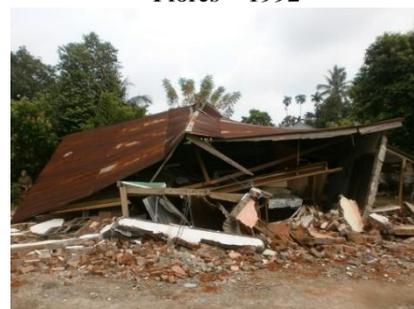
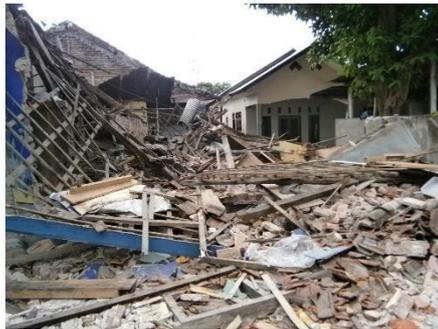
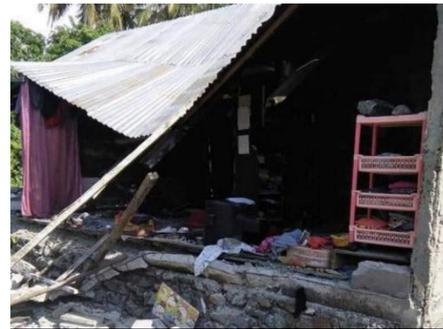
In Indonesia on the average every two years, there is a disastrous earthquake that caused many non-engineered constructions (mostly common people's houses and one-story school buildings) collapsed and killed people (Figure 1). This is a clear indication that those non-engineered construction are not earthquake resistant.

Fig. 1 Damage of non-engineered constructions in Indonesia [1]

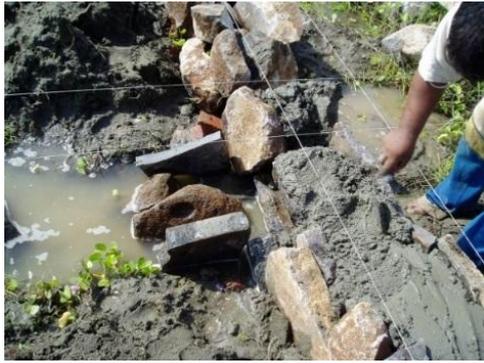
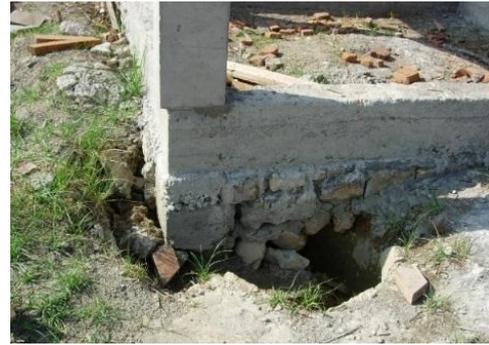
Fig. 4 Improper stone foundation [1]

In general, the damage and collapse of those non-engineered reinforced masonry houses during earthquakes are mostly caused by the poor quality of materials (Figure 3) and poor workmanship, resulting in, among others insufficient or improper foundation (Figure 4), poor detailing (Figure 5), poor mortar quality, poor concrete quality (Figure 6), and poor brick-laying (Figure 7). Besides that, it is a common practice that roof trusses are not strongly anchored to the ring beams. The reinforcement of the practical columns and beams are mostly not in accordance with the requirements. The reinforcing bars detailing are also not appropriately done for earthquake resistance. Therefore, the houses are constructed based on wrong prevailing practice.

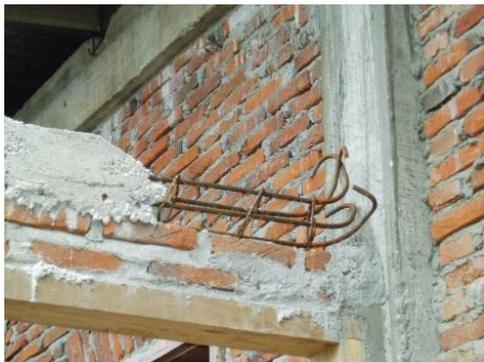
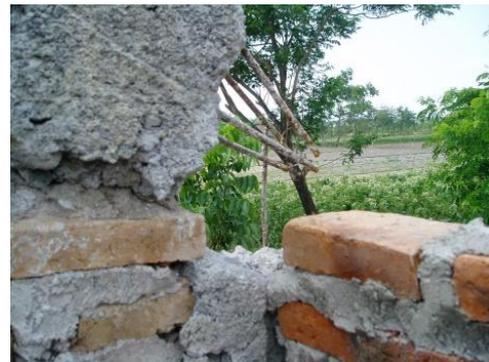
Fig. 5 Poor detailing of reinforcing bars [1]

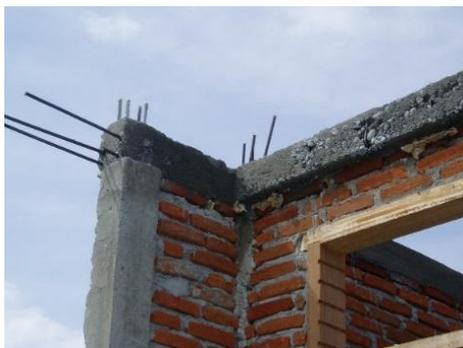
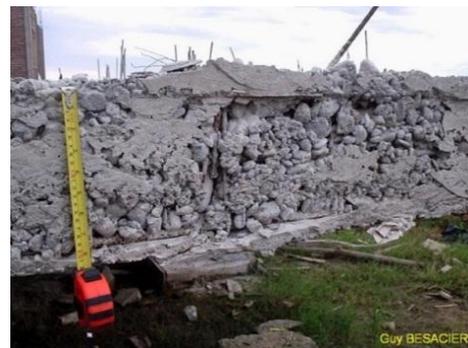
Fig. 6 Poor concrete quality [1]

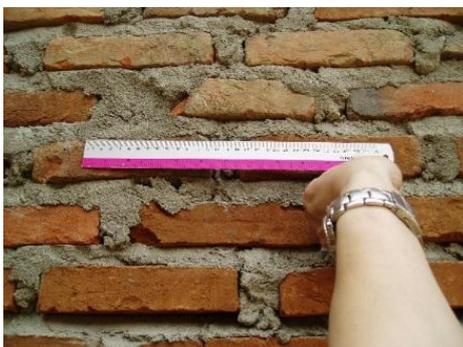
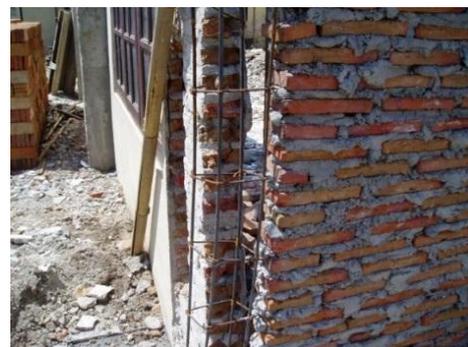
Fig. 7 Poor brick laying [1]

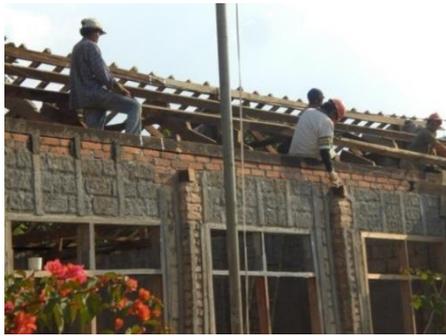
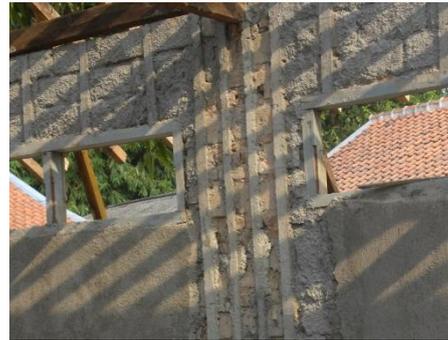
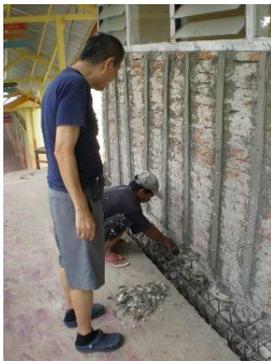
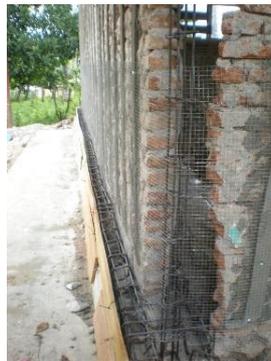
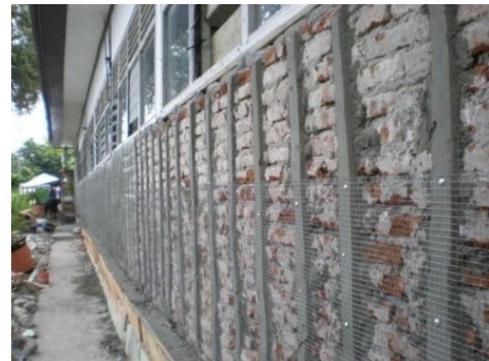
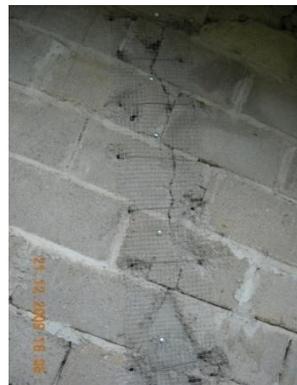
SDN Padasuka II Soreang

SDN 13 Batu Gadang, Padang

Retrofitting house at Balai Baru

Fig. 9 Example of retrofitting buildings using ferrocement as strengthening layers

applied in West Sumatra, 2009. In 2009, the first author did strengthen many damaged people's houses as well as school buildings and engineered constructions using ferrocement layers and provided the analysis (Figure 9).

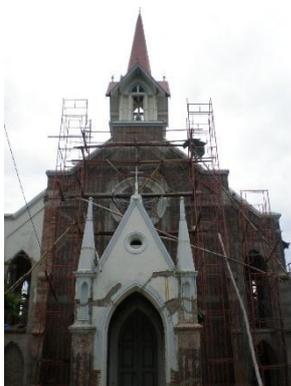
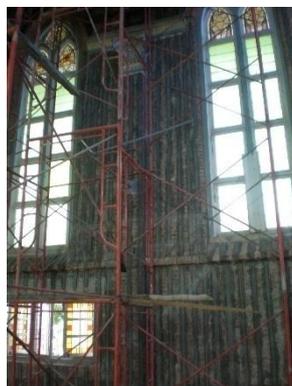
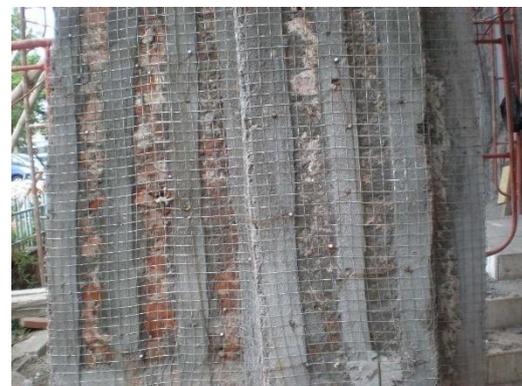
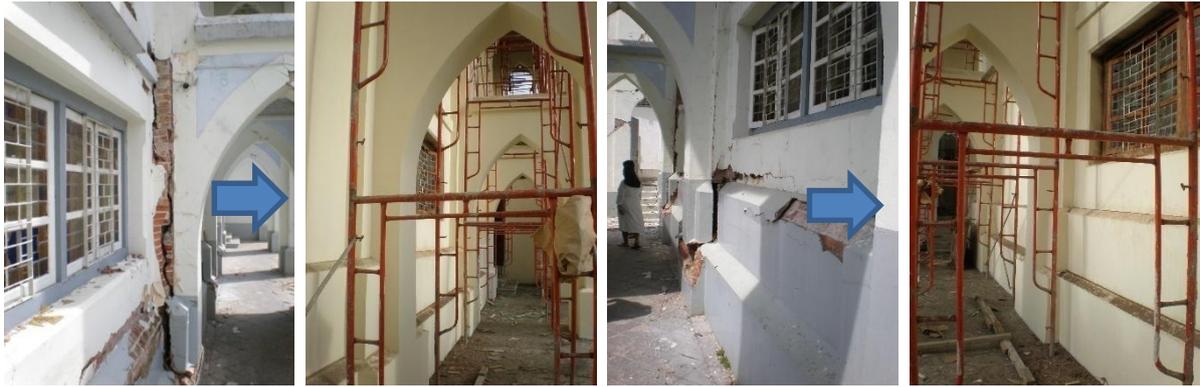
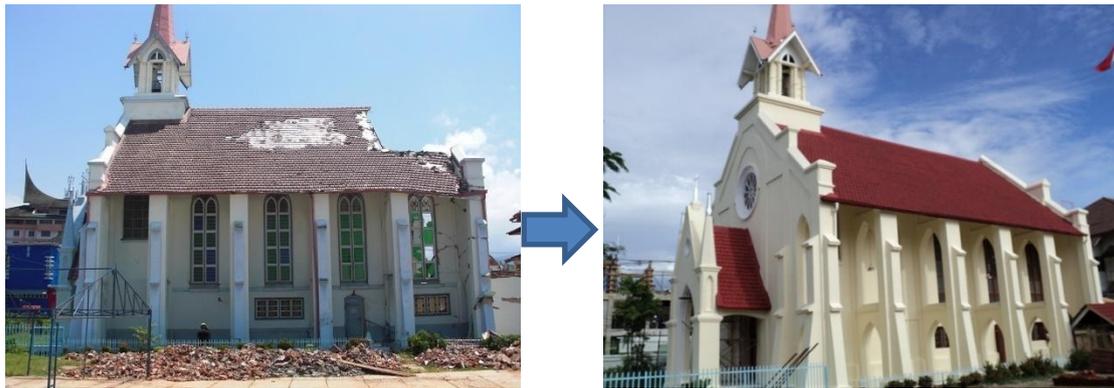
Retrofitting a heritage church, Kapel St. Leo, Padang

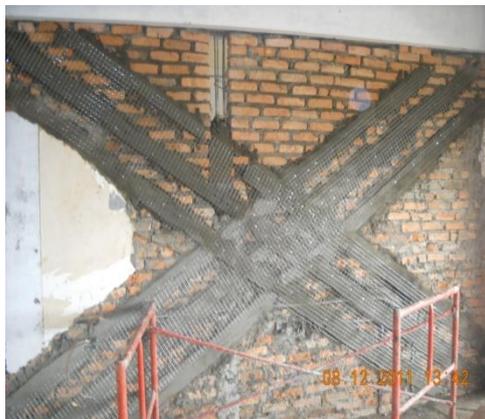
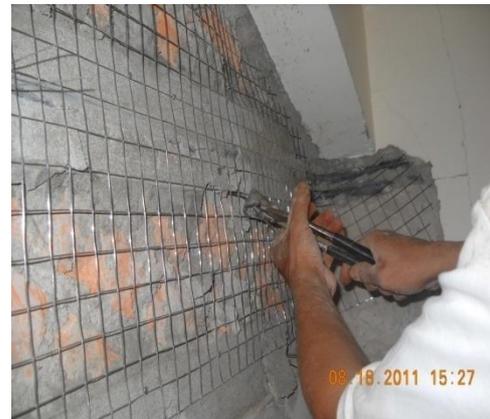
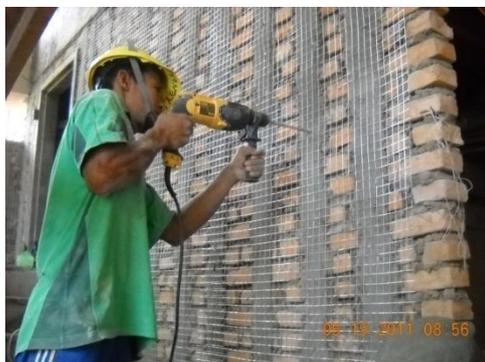
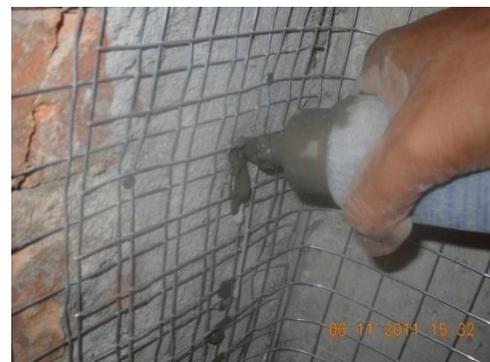
BumiMinang Hotel, Padang

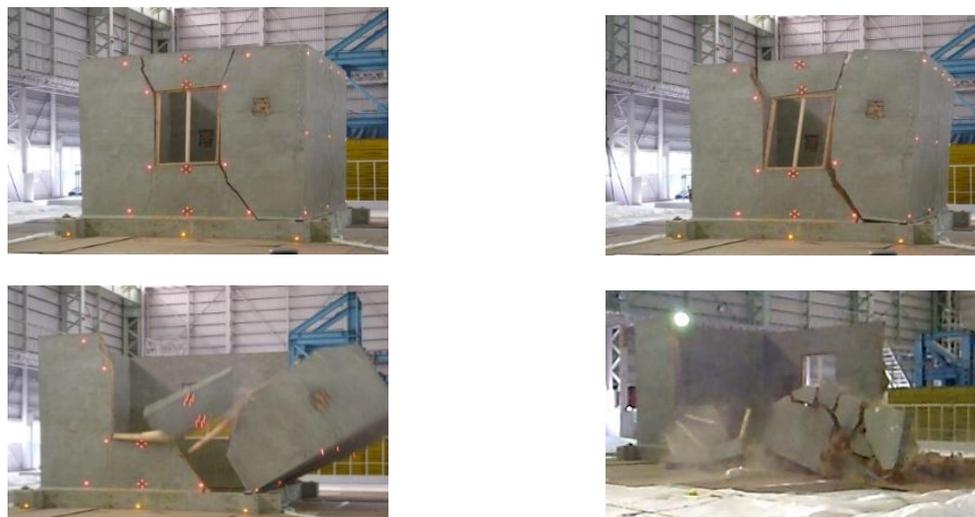
Sequence pictures of the collapsed of unreinforced masonry walls

Fig. 10 Shaking table test of masonry building strengthened using ferrocement overlay, 2012

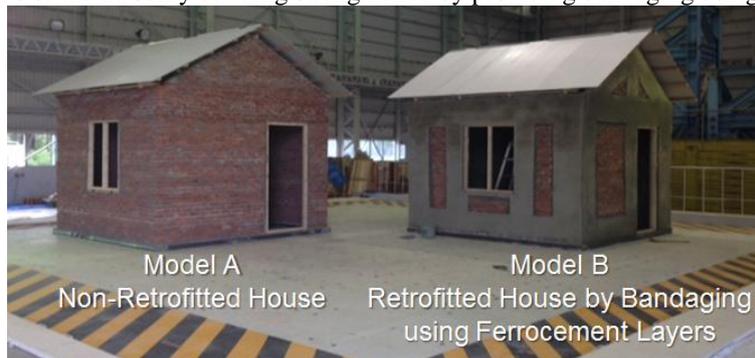
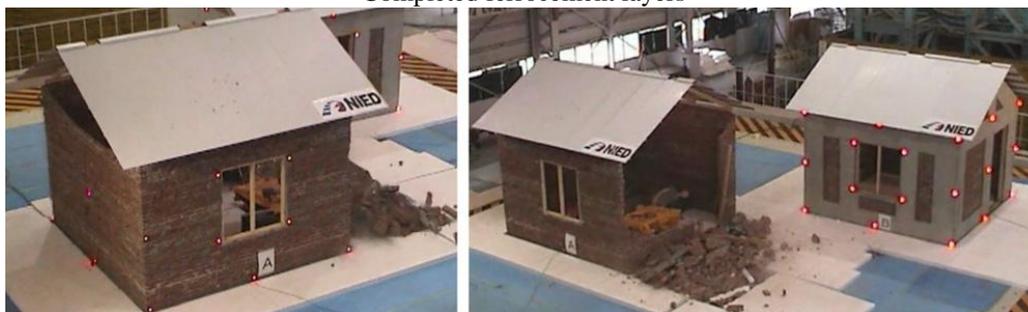
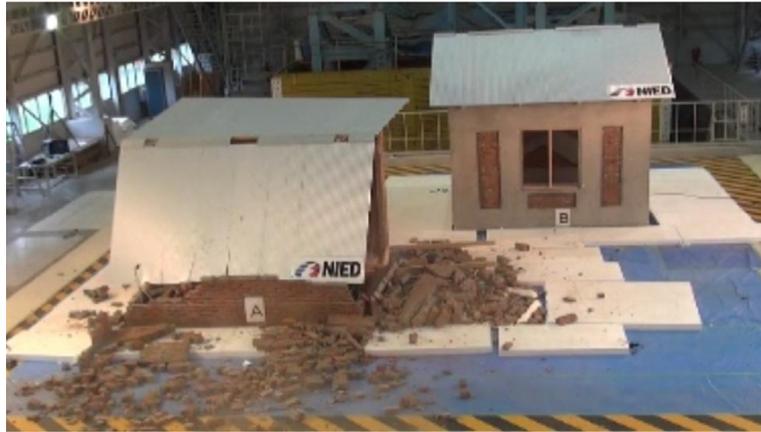
Completed ferrocement layers

Gable wall Model A collapsed due to 100% JMA Kobe; Model B survived

2g JMA Kobe input motion: Model A collapsed and Model B still standing

Fig. 12 Shaking table test of the masonry building strengthened by providing bandaging using ferrocement layers, 2014 [1, 14]

After the successful test, the first author suggested not to **wrap** the wall with ferrocement layers but to bandage only. In 1980, strengthening by **bandaging** masonry walls with ferrocement layers was already introduced in the Guidelines for Earthquake Resistant Non-Engineered Construction [4]. For the purpose, the first author did the analysis for the strengthening of masonry walls by bandaging using the sandwich analogy and the results were good enough. In 2014, NIED and the second author invited the first author to do a full-scale shaking table test in Tsukuba for masonry buildings **bandaged** with ferrocement layers. There were two model structures built on the shaking table in NIED, Tsukuba. Both models were of the same size and built as unreinforced masonry building (without RC confinement columns and beams). The first model (Model A) the original unreinforced masonry structure without plaster, and the second (Model B) the same masonry structure strengthened by providing bandaging using ferrocement layers on both sides of the walls, acting as sandwich structures. The analysis was explained prior to the testing. The test results were very successful and matched with the analysis performed (Figure 11 and Figure 12). The report of the shaking table test was published in the Journal of Disaster Research [14].

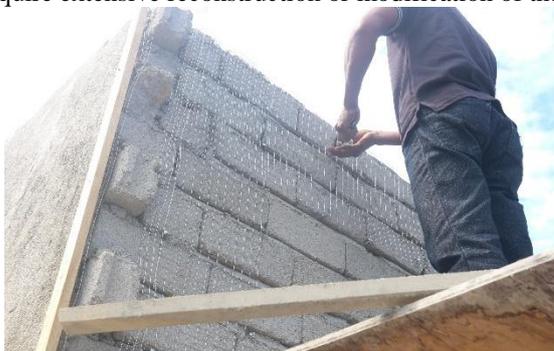
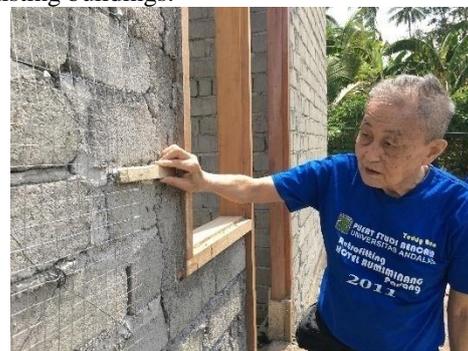
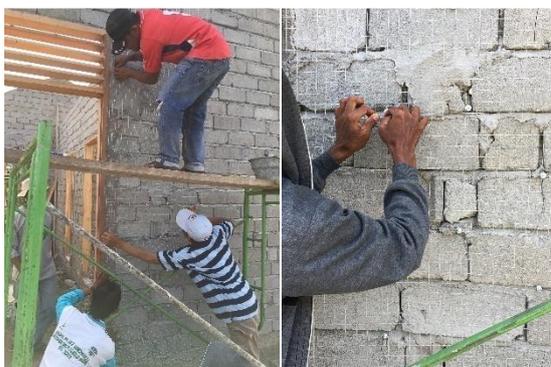
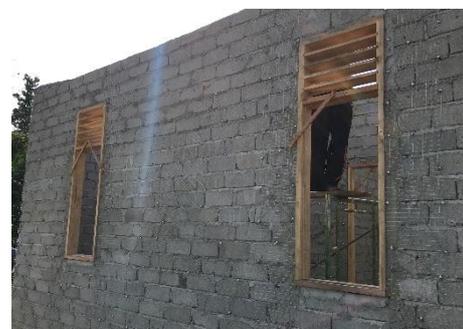
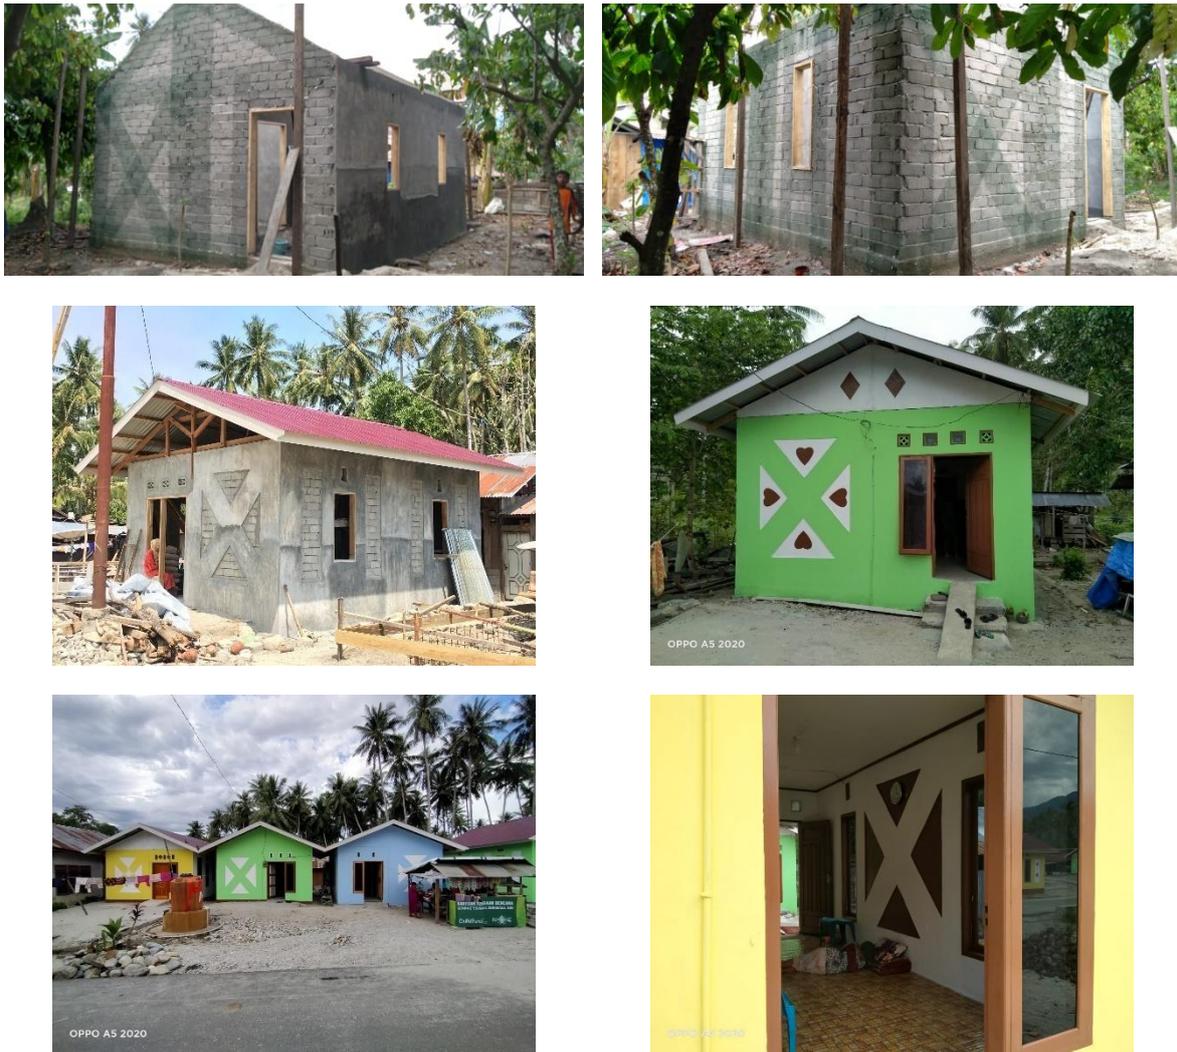
Fig. 13 Masonry houses using ferrocement bandaging (Palu, 2020)

The use of ferrocement for strengthening masonry walls is categorized as “appropriate technology”. Meaning of appropriate technology is a method, simple to use, affordable, replicable, using local material and local masons. To overcome the shortcomings mentioned previously in constructing Indonesian masonry houses (Figure 2), the first author introduces a new method of constructing people’s housing, using ferrocement bandaging and abandoning the use of the so-called practical columns and practical beams (Figure 13). The first author also purposed to replace the rubble stone foundation with an inverted RC T-beam (Figure 14). This is to make the construction of people’s houses much simpler and stronger. The advantages of constructing masonry houses bandaged using ferrocement layers are:

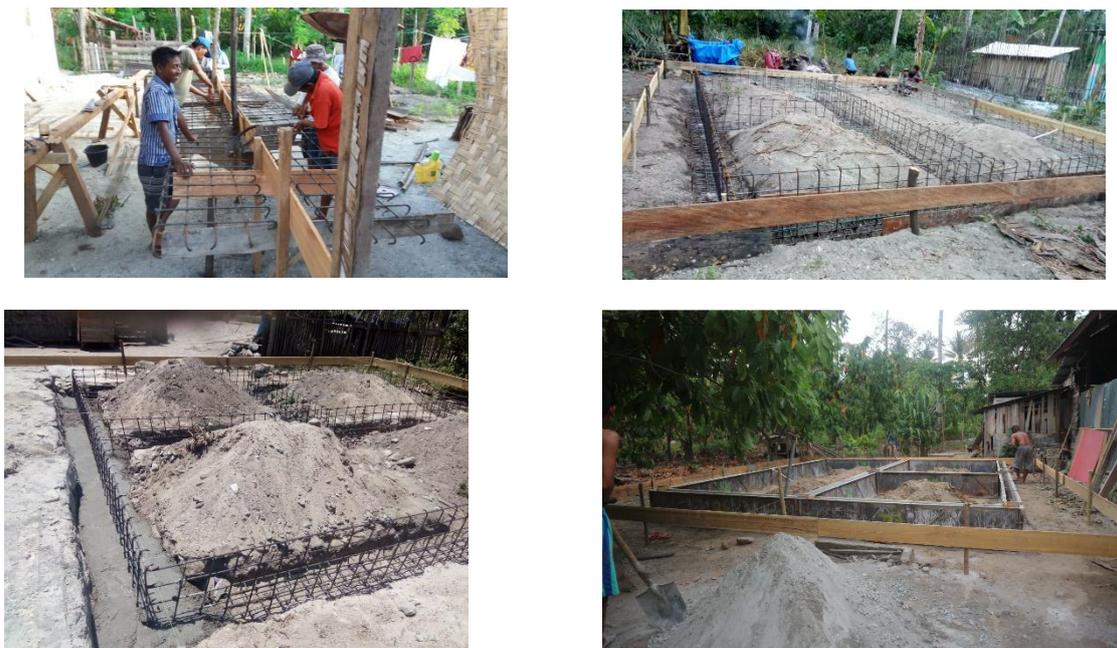
Fig. 14 Inverted RC T-beam (Palu, 2020)

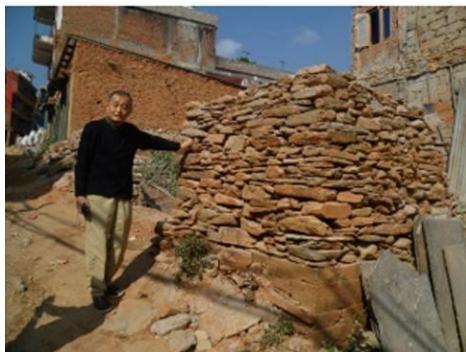
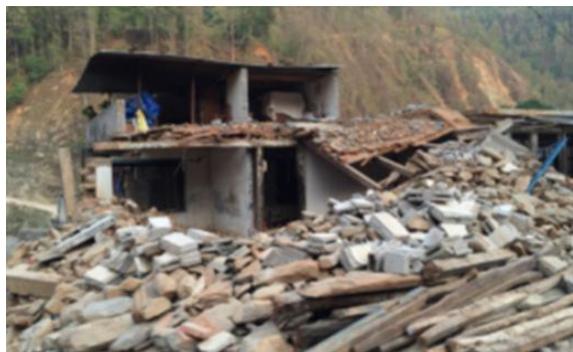
During the April 25, 2015 Nepal earthquake, approximately 262,600 buildings were damaged, and 489,500 buildings collapsed [15]. Unfortunately, most of the buildings in the mountainous regions of the Himalaya in Nepal that collapsed were non-engineered buildings, i.e. mud mortar stone/brick masonry houses (Figure 15).

Fig. 15 Mud mortar stone masonry houses collapsed due to April 25, 2015 earthquake [16]

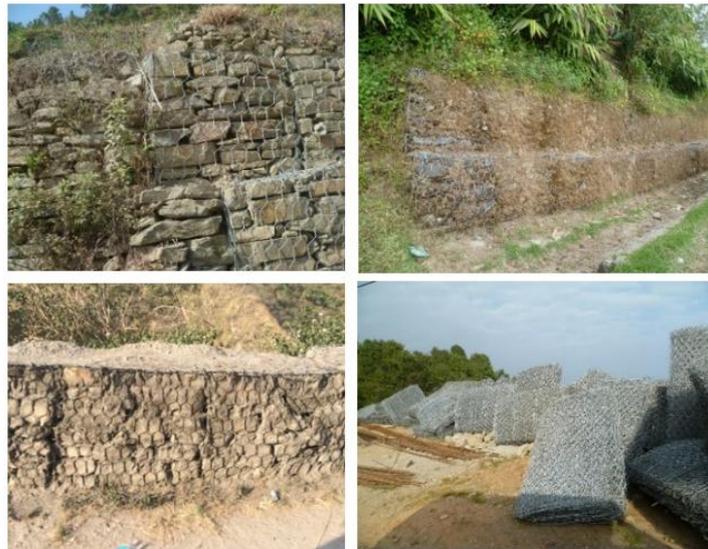
After surveying for 3 days along the Himalayan mountainous regions, the first and second authors observed that along the mountainous routes, many slope embankments were protected by gabions and none of them were damaged during the 2015 April earthquake (Figure 16). The first and second authors also found that in the mountainous regions the use of gabions is common and there are even "several big storages of gabion wires". The use of gabions in the Himalayan regions can be categorized as using appropriate technology because stone is free, gabion wires net are easy to get and people are very familiar on how to construct gabions.

Fig. 16 Gabion is used as retaining walls [16]

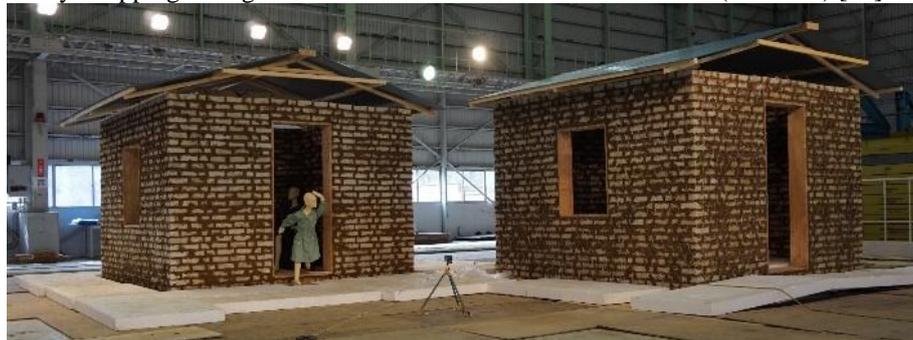
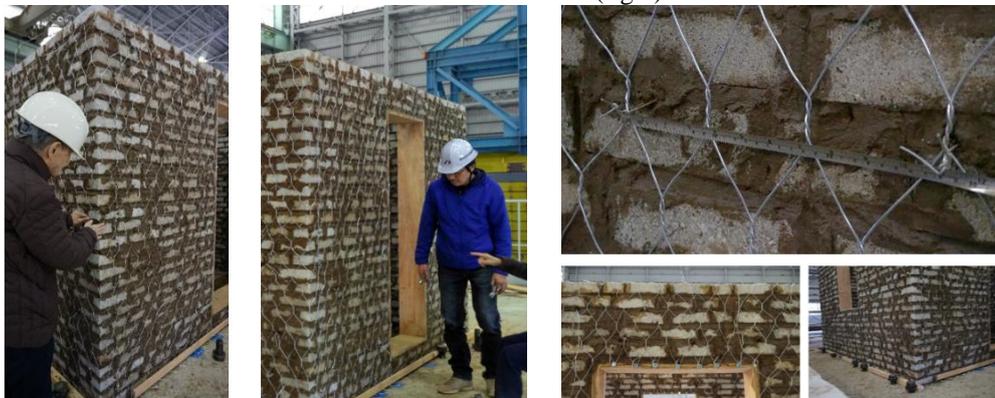
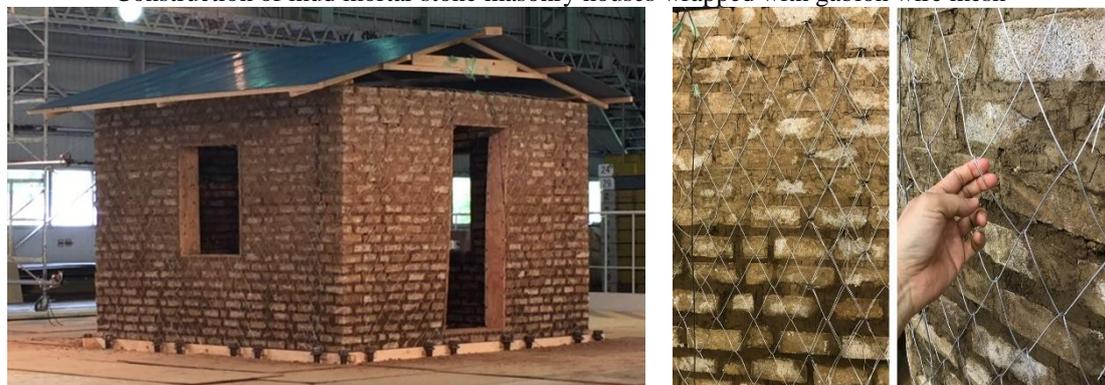
Model A – Non-Retrofitted unreinforced mud mortar stone masonry without plaster (left); Model B – Retrofitted unreinforced mud mortar stone masonry strengthened by wrapping 2mm gabion wire mesh on both sides of the walls (right)

Construction of mud mortar stone masonry houses wrapped with gabion wire mesh

Model B, mud mortar stone masonry strengthened by wrapping 2mm commercial type gabion wire mesh on both sides of the walls, constructed at the end of May 2019

Fig. 18 Full shaking table test of mud mortar stone masonry houses [16]

The proposed method was analyzed by the first author and the analysis results show that during a strong earthquake, the wrapped mud mortar stone masonry walls will be deformed substantially but do not collapse (Figure 17). On February 26, 2019 and June 4, 2019, a full scale shaking table tests for mud mortar stone masonry houses were conducted in Tsukuba by NIED in cooperation with the second author and the association of gabion manufacturers of Japan. The shaking table tests demonstrated that the strengthening using gabion wire mesh, is effective in preventing collapse of mud mortar stone masonry walls when shaken by earthquakes (Figure 18). This shaking table test was published in Journal of Scientific and Engineering Research [16]. Therefore, the "traditional" practice to build mud mortar stone masonry houses strengthened by wrapping with 2 mm gabion wire mesh can save human lives. Wrapping gabion wire mesh to existing houses can be done without too much disturbance, therefore, it is suitable for strengthening all the existing mud mortar stone masonry houses in Nepal.

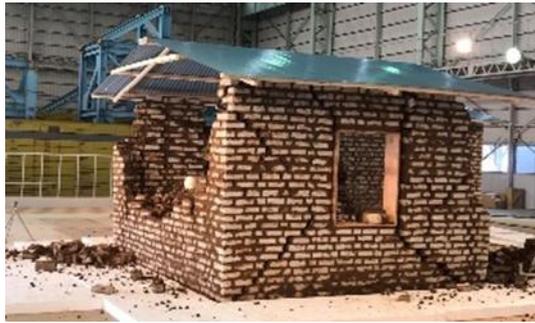
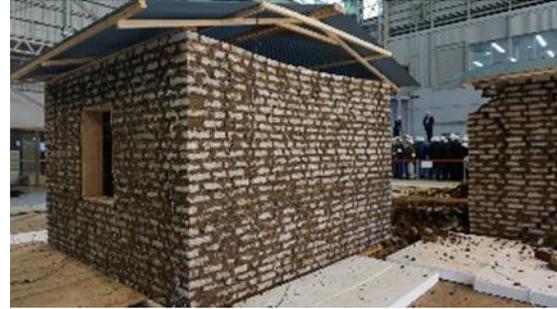
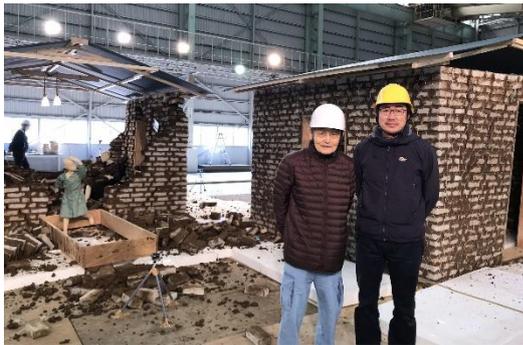
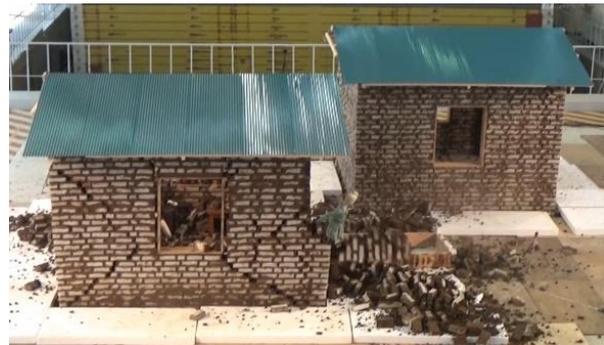
Model A: West and East walls collapsed due to out-of-plane loading; large cracks from window openings in North and South walls (left); Model B: Deform but did not collapse (right)

The first and second authors – Model A collapsed and Model B still standing due to 70% JMA Kobe

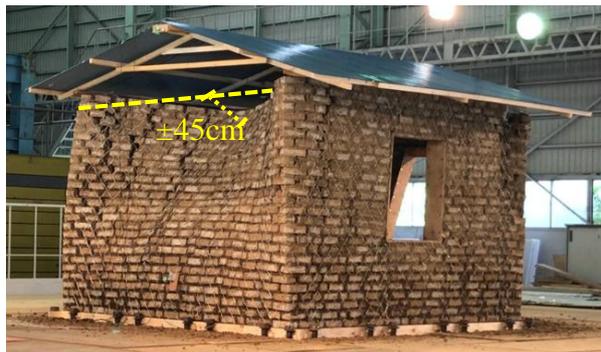
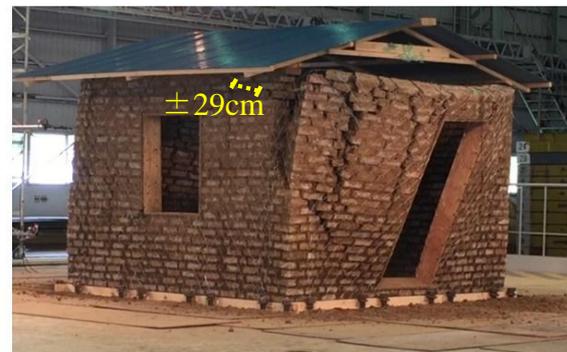
West Wall

East Wall

June 4, 2019 shaking table test with 100% JMA Kobe input motion for Model B only: substantial cracking and deformations but did not collapse.
